GEOCON PROJECT NO. S2851-05-02

DECEMBER 2024

Subject: GEOTECHNICAL INVESTIGATION JADA WINDOWS GRASS VALLEY, NEVADA COUNTY, CALIFORNIA

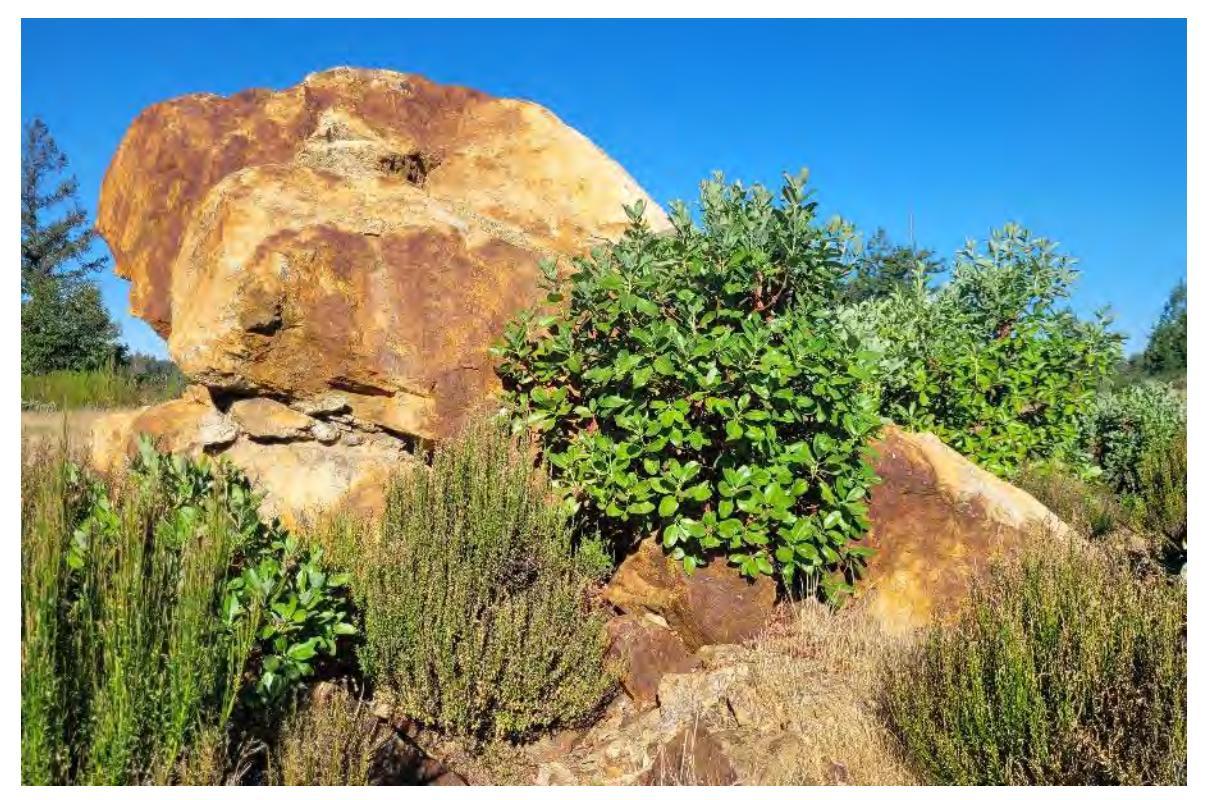
Photo 2 – Rock outcrop, approximately 10 feet above grade, in the central portion of the site.

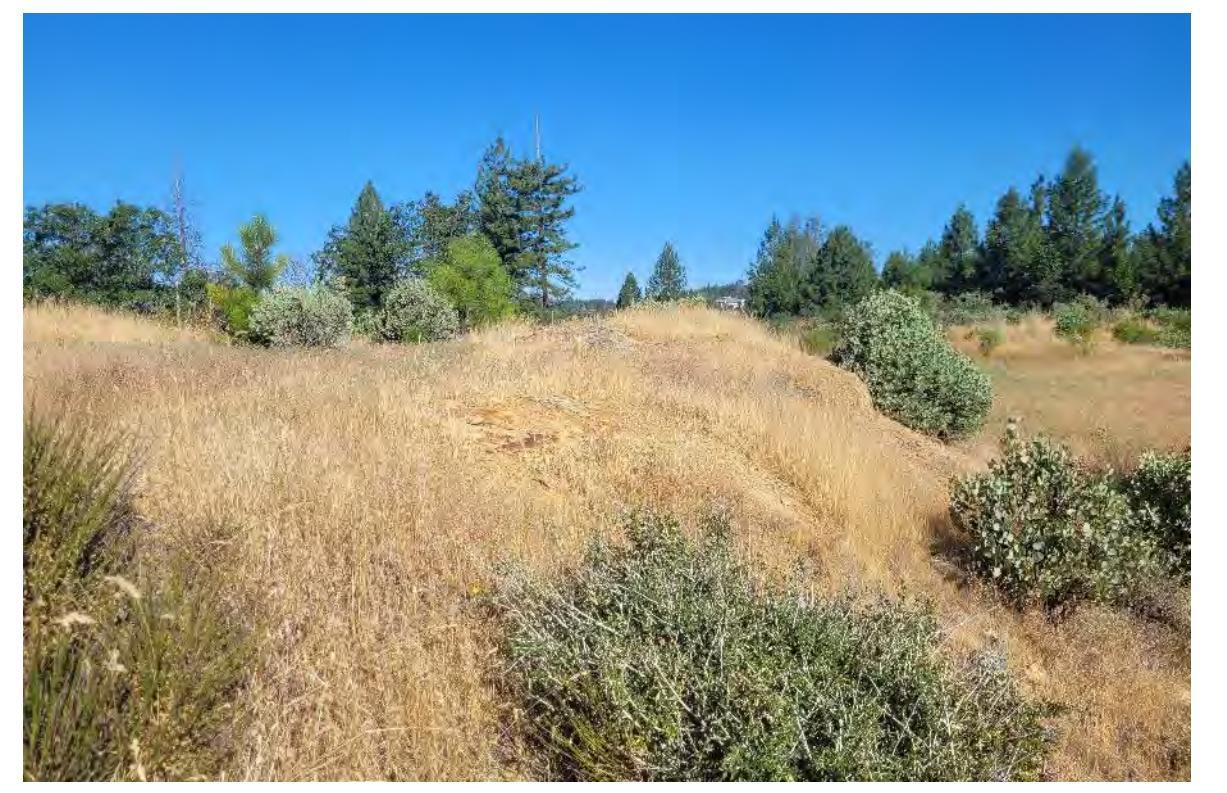
Photo 3 – Resistant diabase rock outcrop, approximately 4 feet above grade, in the central portion of the site.

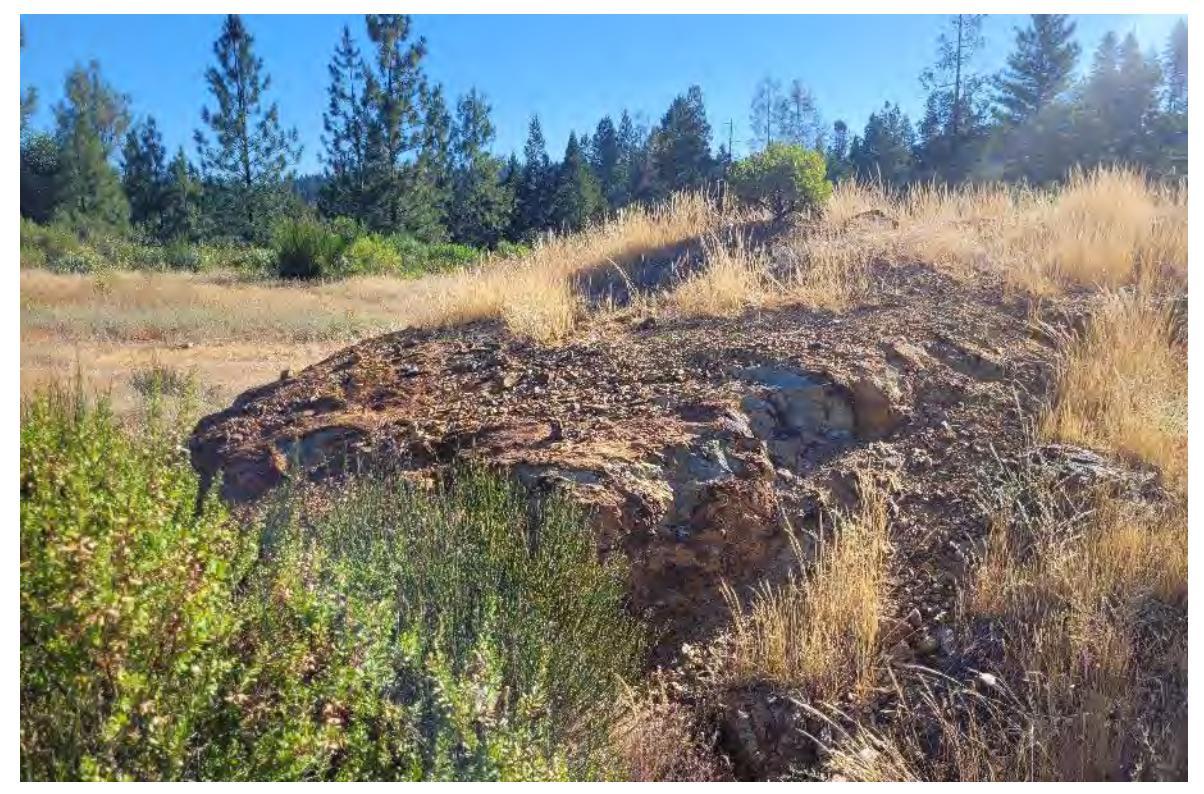
Photo 4 – Area of more resistant diabase rock outcrop in the central portion of the site.

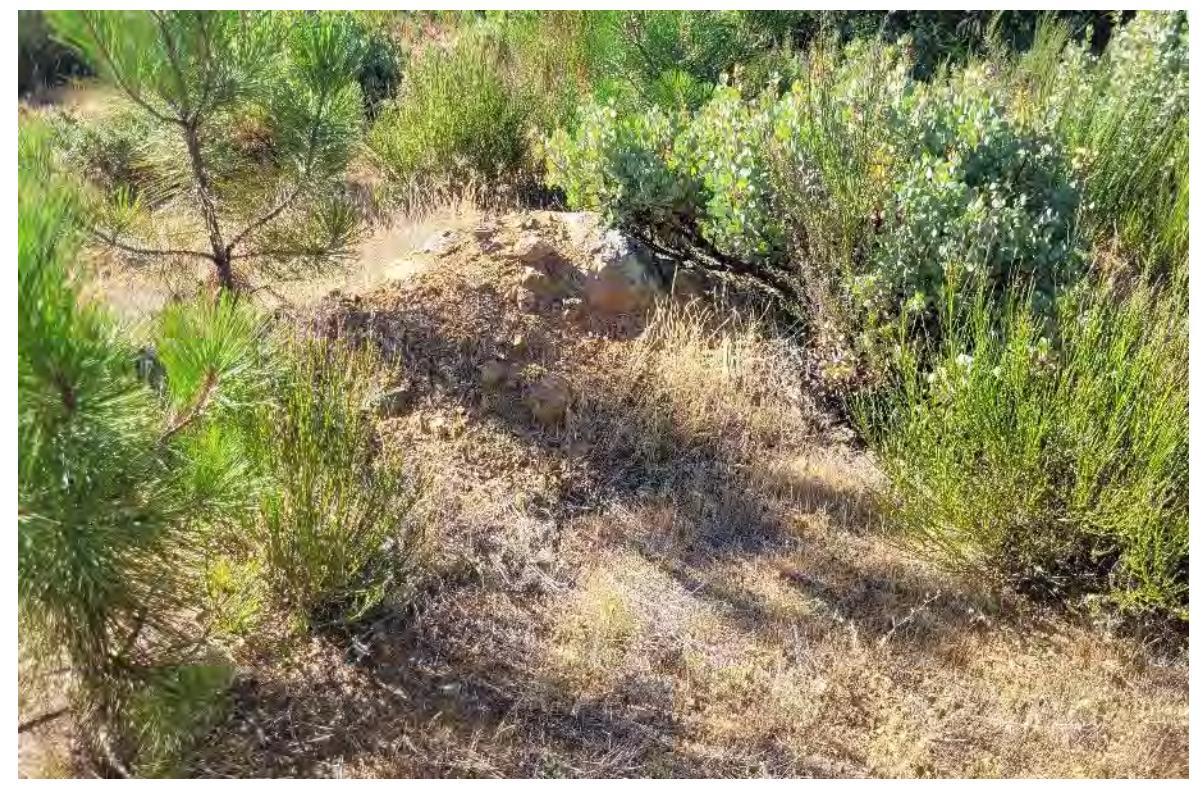
Photo 5 – Typical diabase rock outcrop in the central portion of the site.

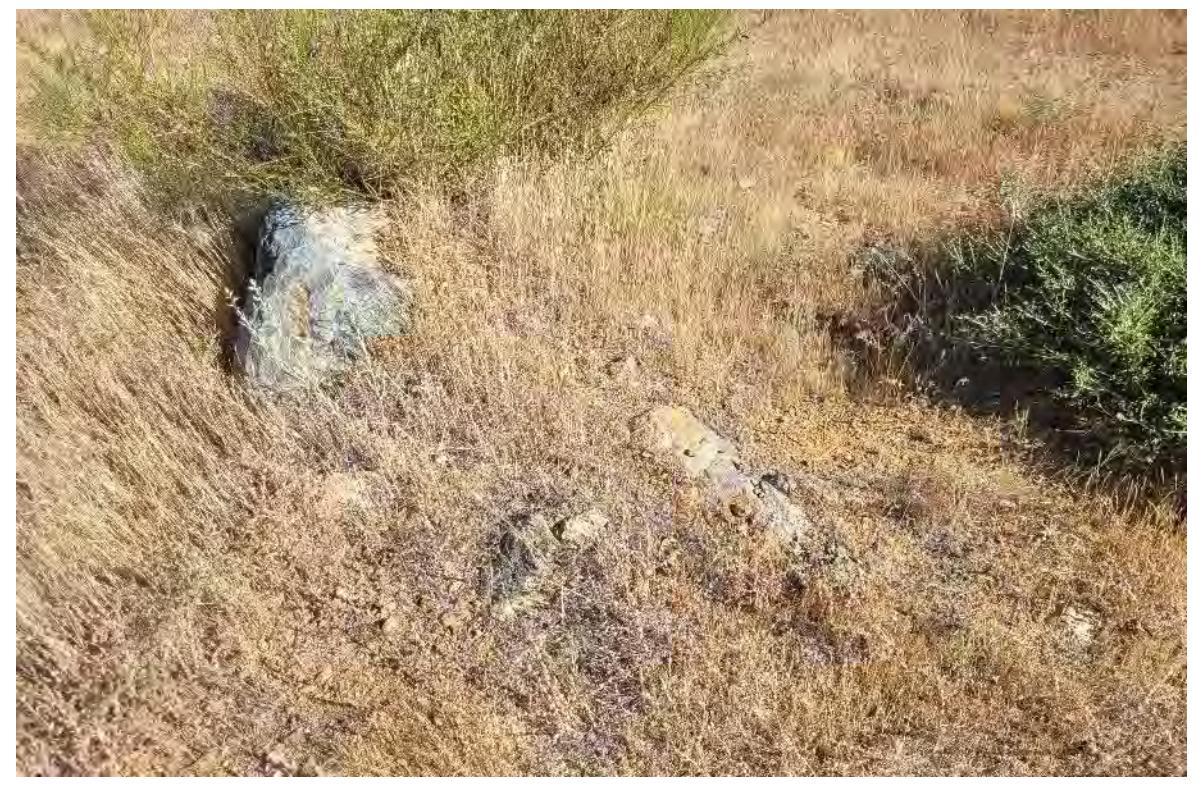
Photo 6 – Typical diabase rock outcrop in the central portion of the site.

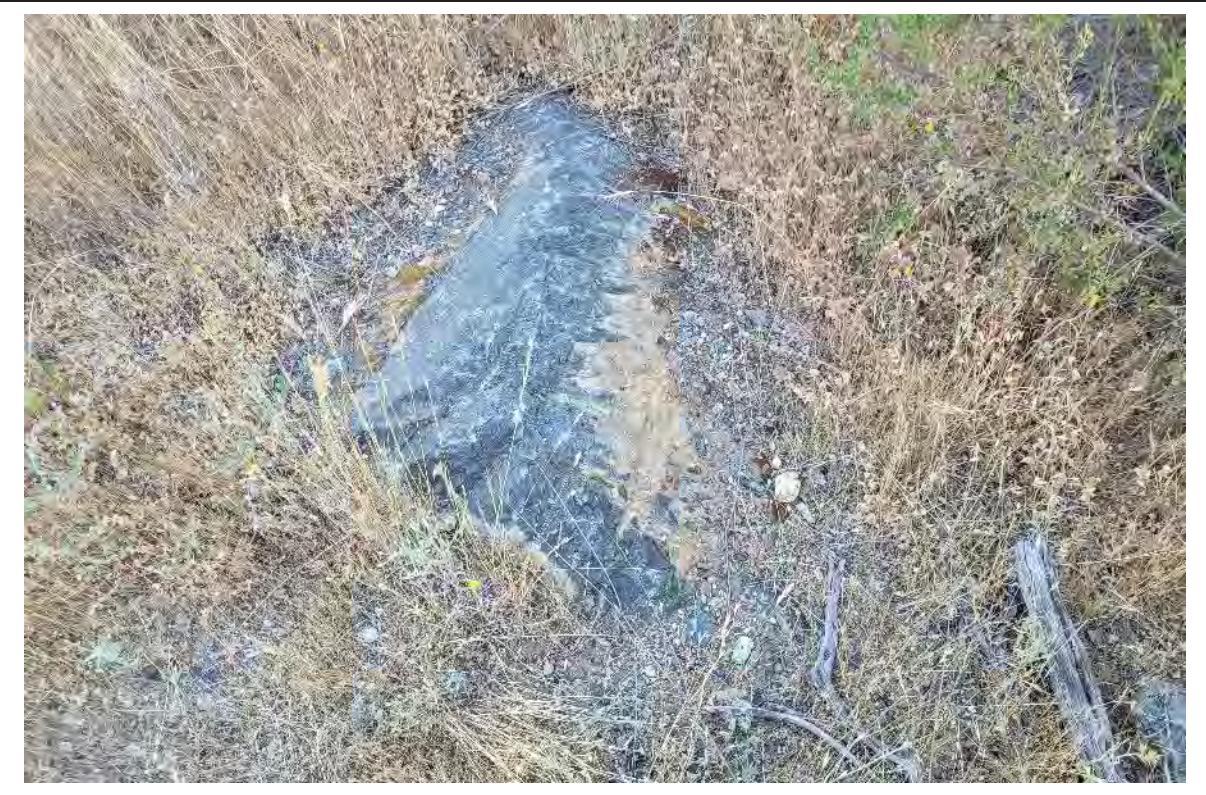
Photo 7 – Typical diabase rock outcrop in the central portion of the site.

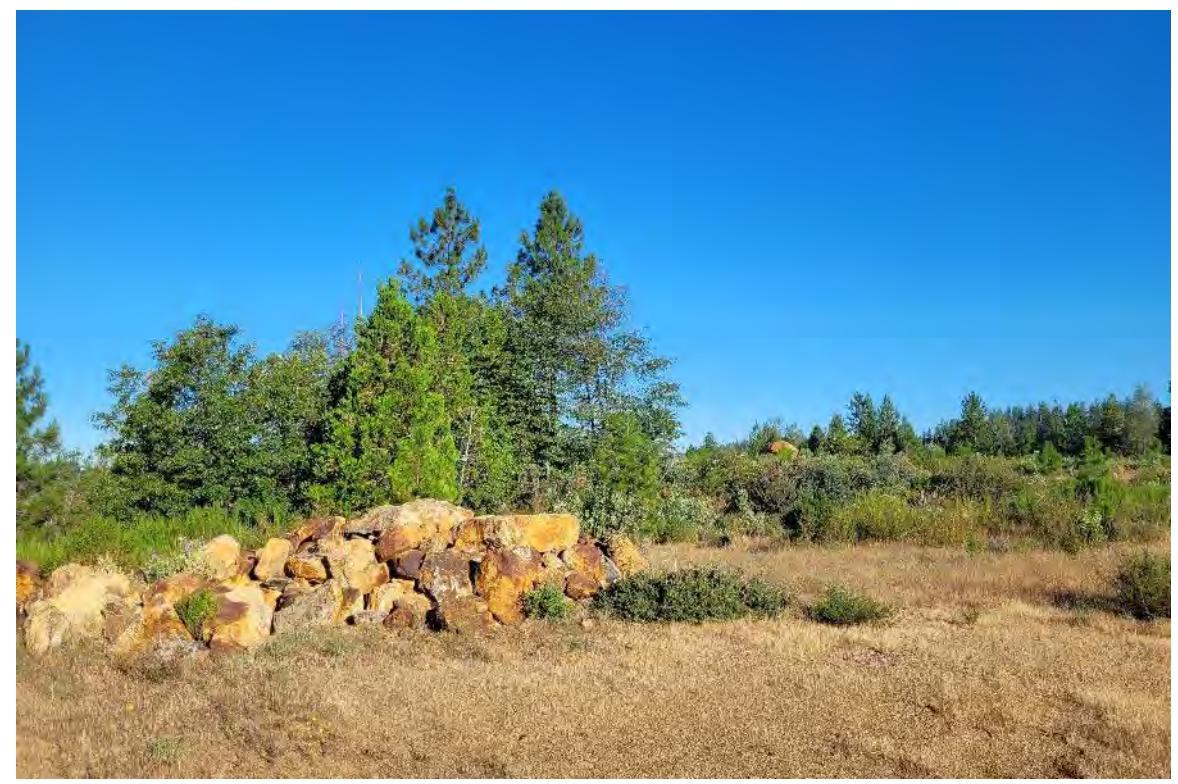
Photo 8 – View to the southwest of boulders, typically up to three feet in maximum dimension, stockpiled in the southeastern portion of the site during previous earthwork grading.

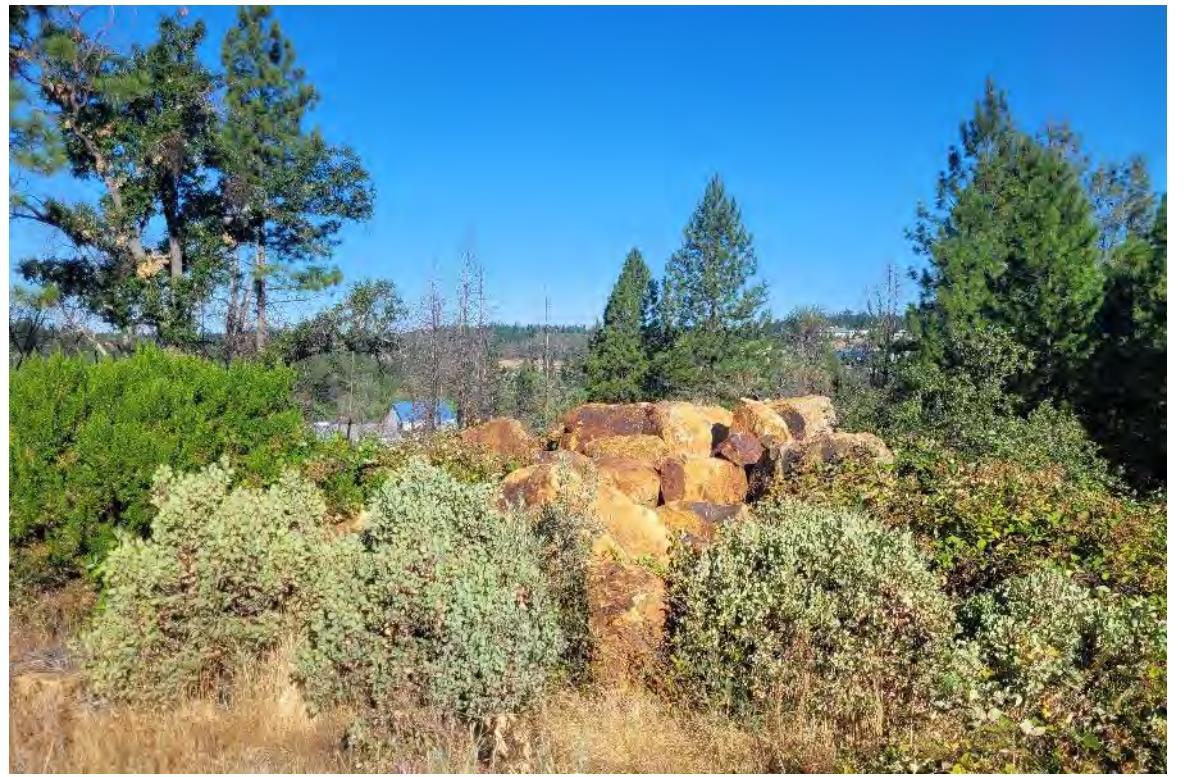
Photo 9 – View to the west of boulders, typically up to five feet in maximum dimension, stockpiled near the northwestern site boundary during previous earthwork grading.

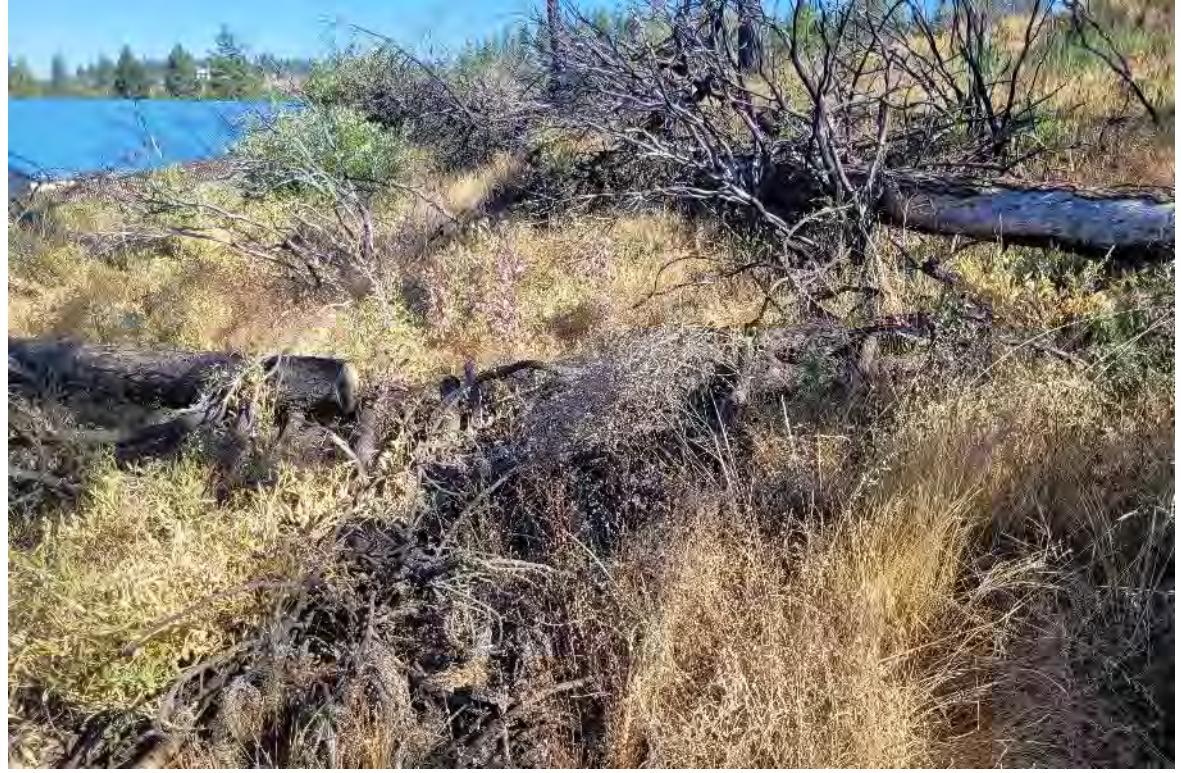
At the historically mapped location of the vertical mine shaft, we observed a shallow depression (Photo 10). We did not observe evidence of a shaft portal, concrete structures, or mine waste at the historically recorded shaft location. The absence of waste rock is likely because the shaft was excavated upward from the underground tunnel, and waste rock from the shaft excavation was likely carried down to tunnel level and out through the Idaho Main Shaft northwest of the site.

Photo 10 – View to the west of the historically mapped Canyon shaft location in the western end of the site. The area is a shallow, densely vegetated depression. No mine rock or concrete was identified.

If improvements are planned within 100 feet of the recorded vertical shaft location, we recommend that the shaft location be determined by survey and the shaft portal be physically closed with a concrete slab or plug. Physical closure, if performed, should be performed under permit with Nevada County and according to an engineered design. Survey data and as-built closure documentation should be retained for future reference.

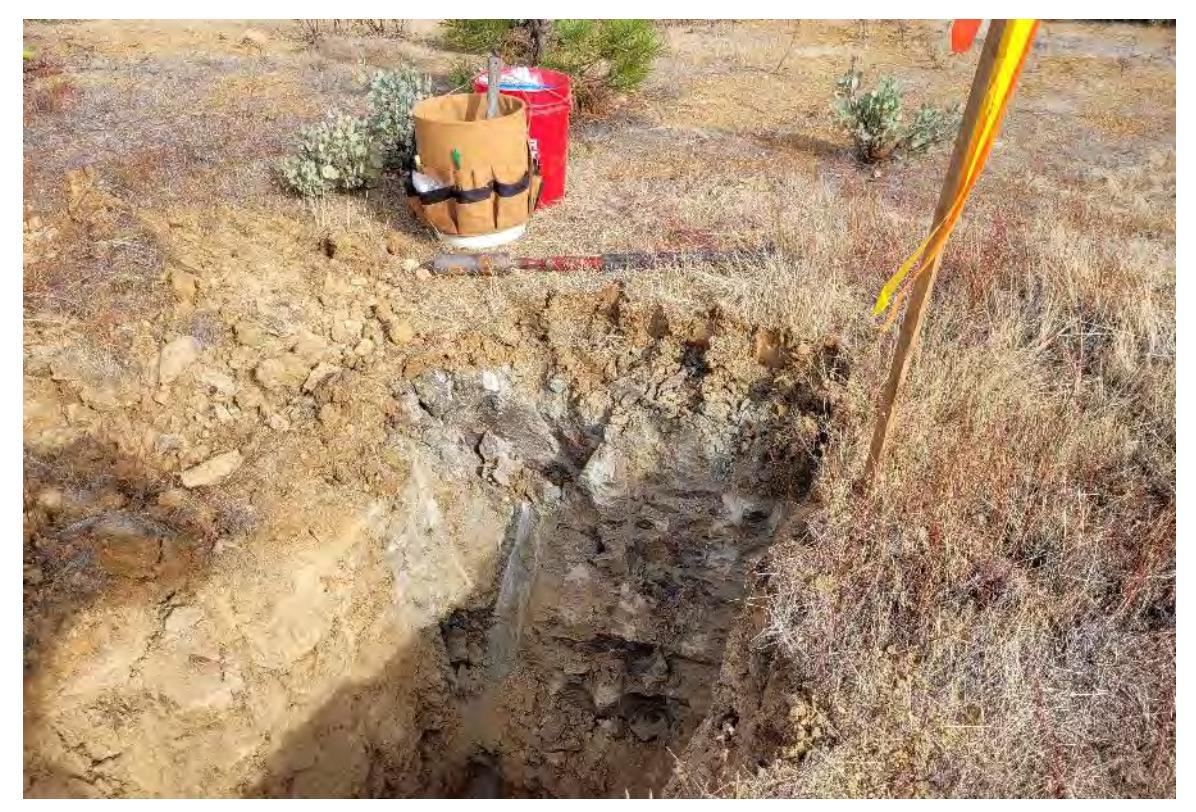
Photo 12 – Variably weathered diabase rock in exploratory trench T24-01.

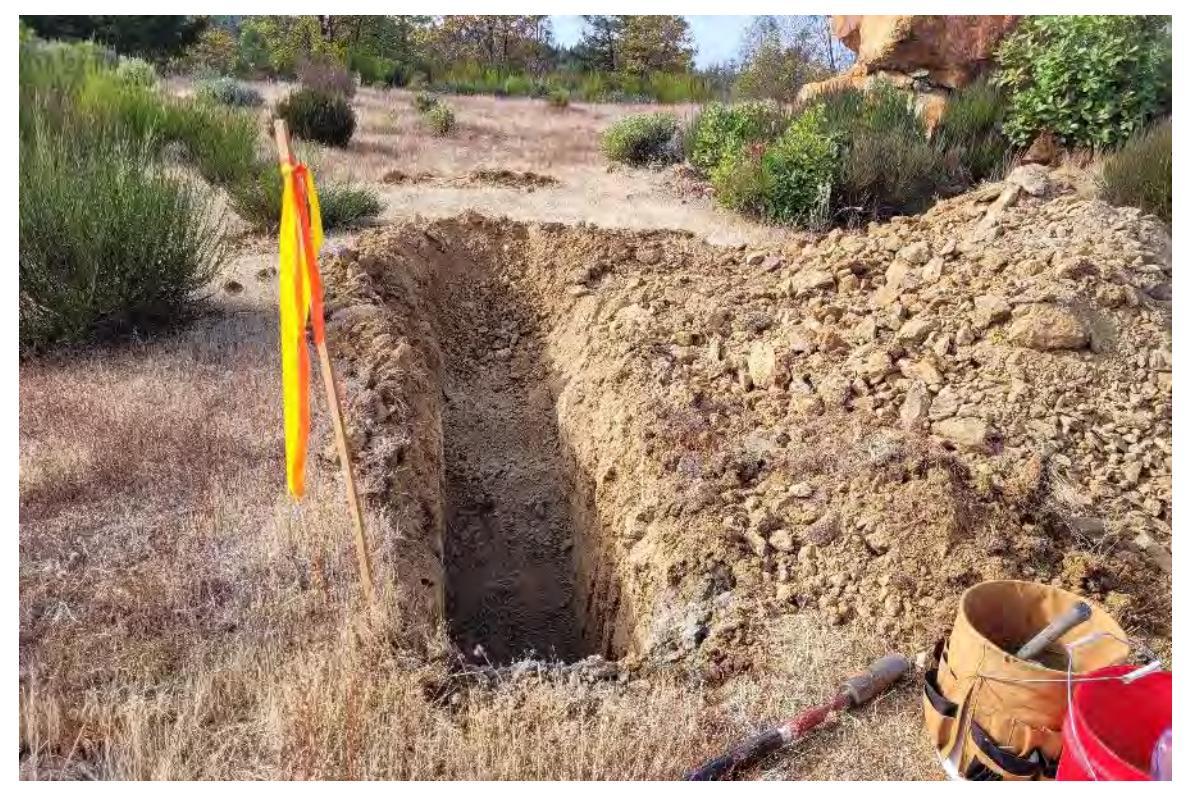
Photo 15 – Variably weathered rock in exploratory trench T24-02.

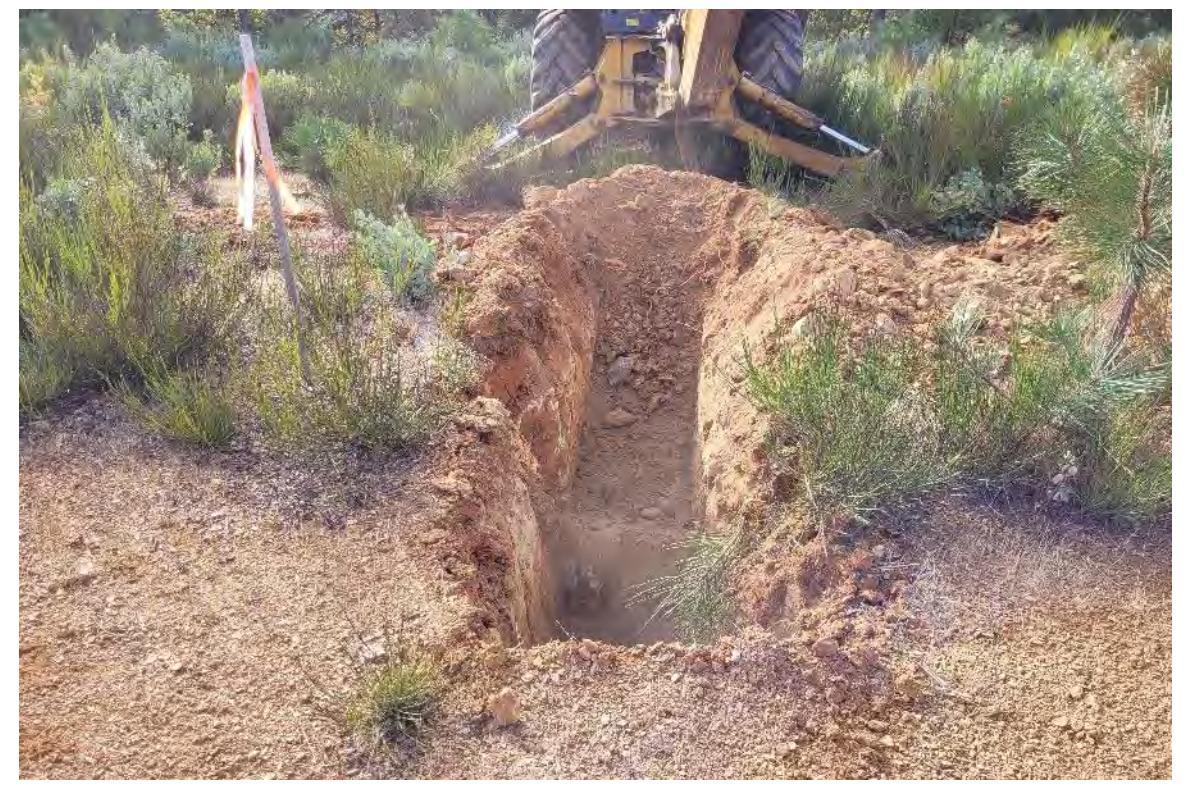
Photo 17 – Variably weathered rock in exploratory trench T24-03.

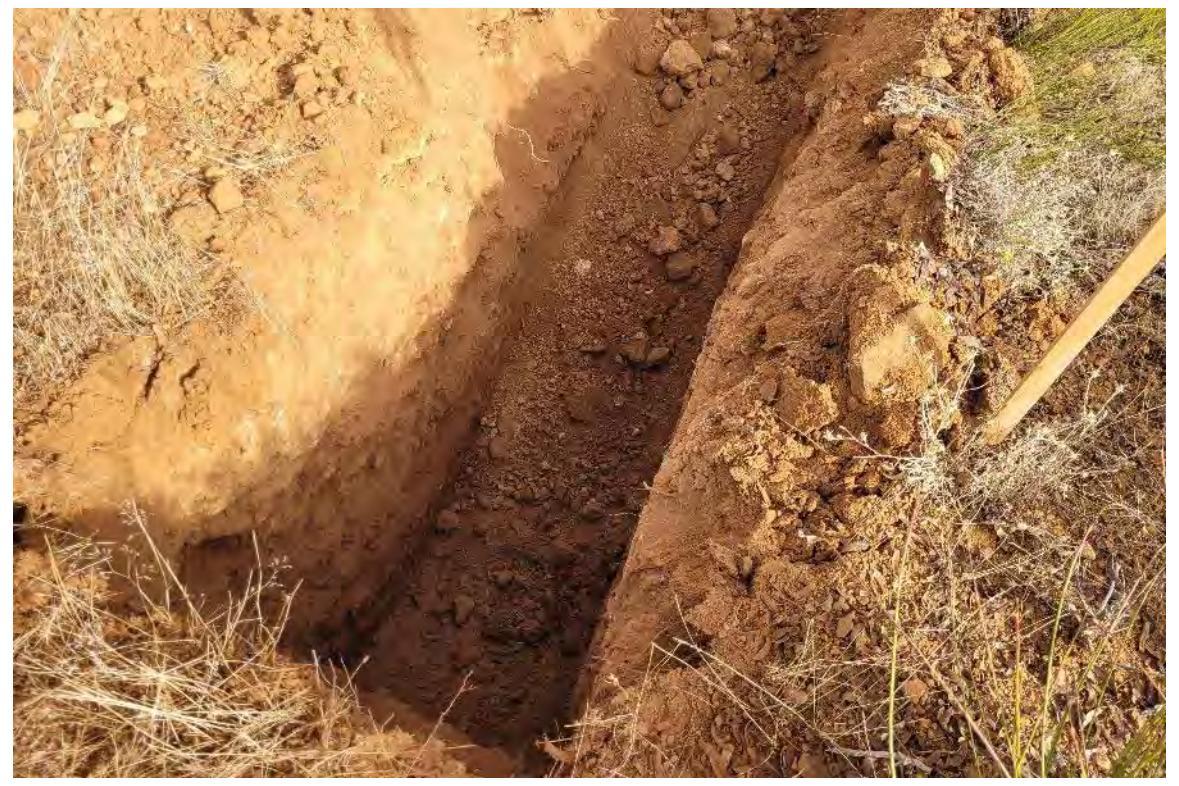
Photo 19 – Engineered fill in exploratory trench T24-04.

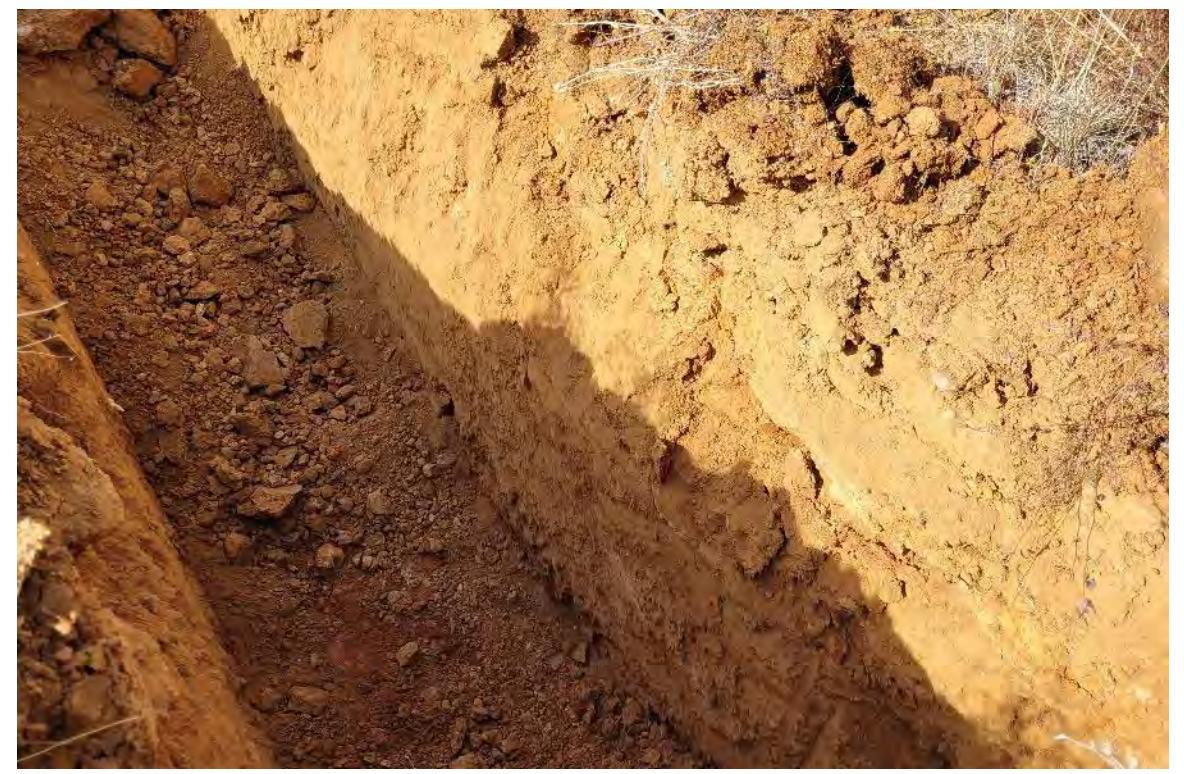
Photo 21 – Engineered fill in exploratory trench T24-05.

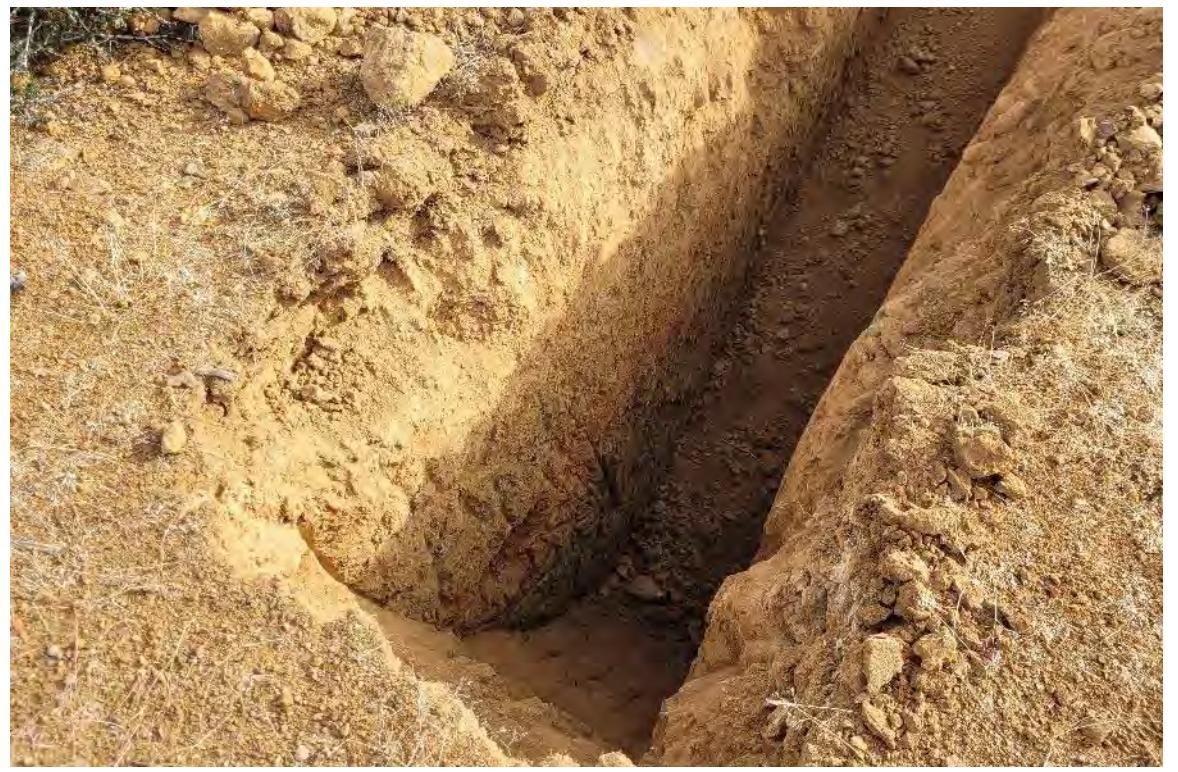
Photo 23 – Engineered fill in exploratory trench T24-07.

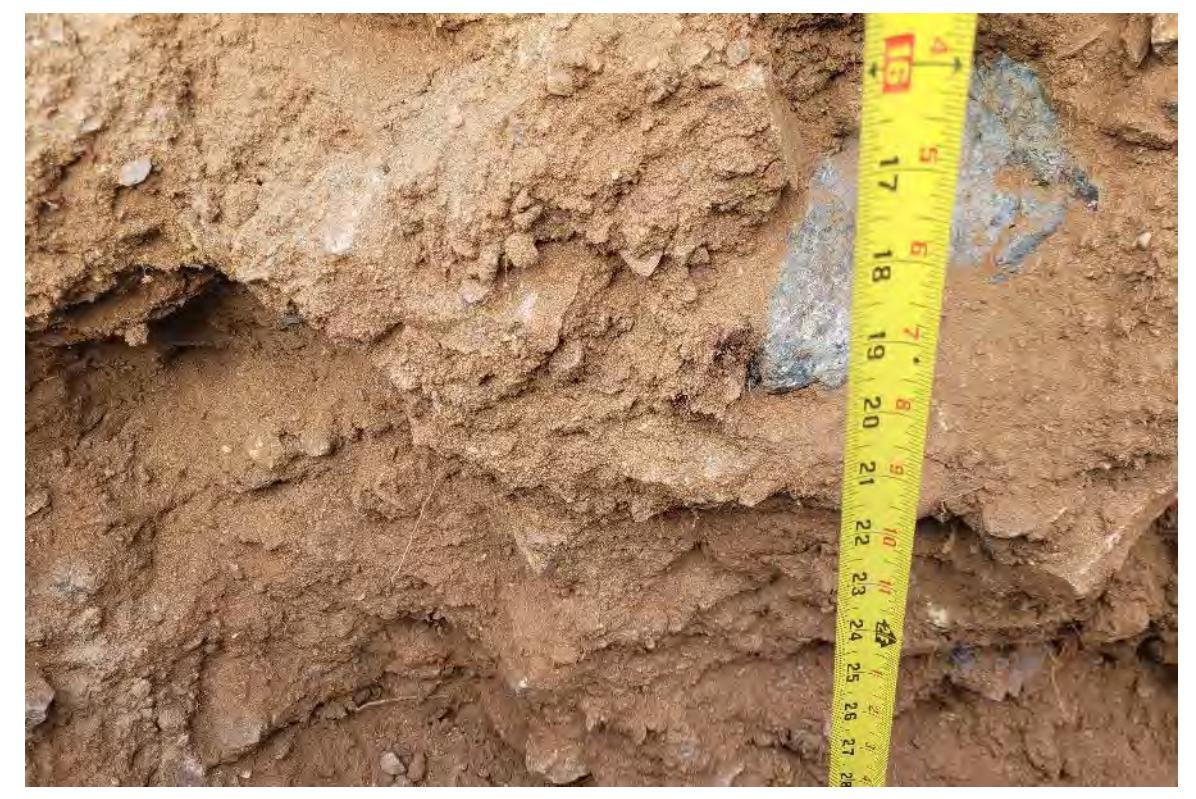
However, we observed untested, undocumented fill at the location of exploratory trench T24-09, as described in Section 3.1 and the exploratory logs (Appendix C). It appears that this undocumented fill was not removed or otherwise remediated during the 2013 earthwork/grading of the site. The undocumented fill is not considered suitable for support of the proposed improvements and should be removed and replaced in accordance with the recommendations presented in Section 6.0. We also observed relatively loose soil in the upper 18 inches of fill at the location of our exploratory trench T24-06 that should also be removed and replaced in accordance with the recommendations presented in Section 6.0.

Photo 26 – Fill with serpentinite rock in exploratory trench T24-09.

The ultramafic rock, undocumented fill, and expansive clay soil in the northeastern portion of the site should be replaced to finish subgrade elevation with engineered fill borrowed from the remainder of the site, outside of the mapped serpentinite area.

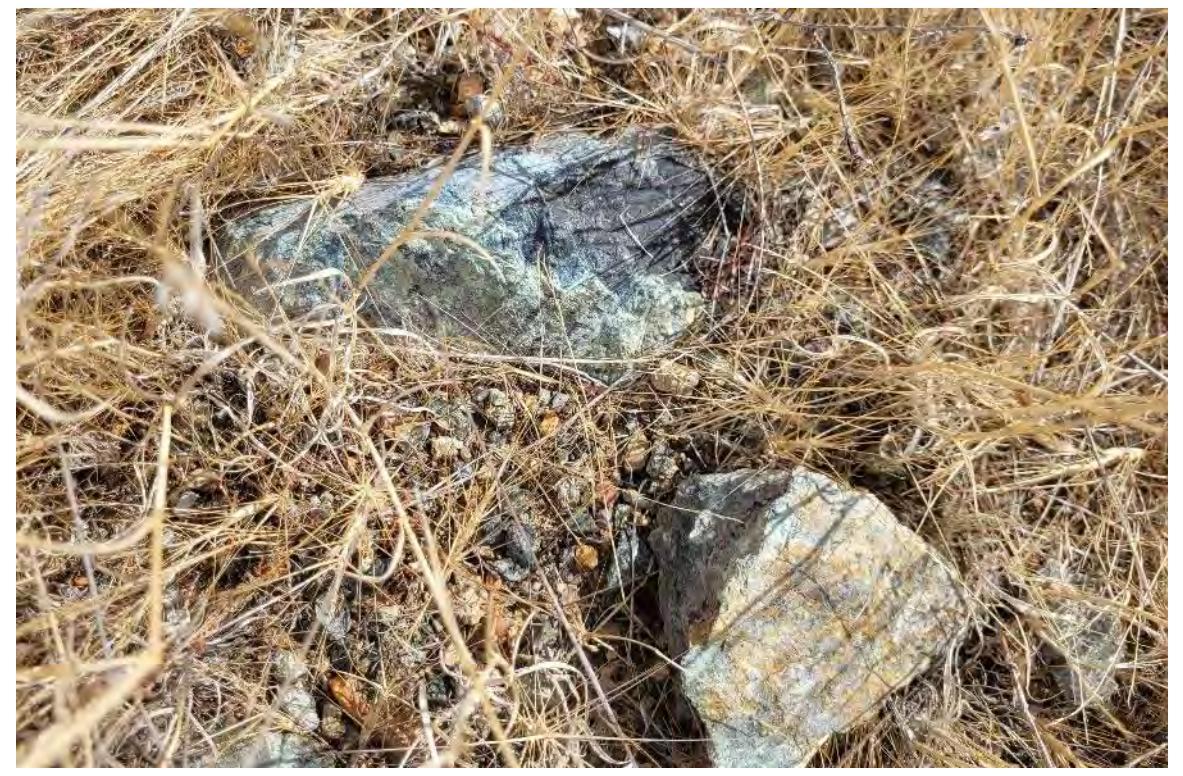
Photo 27 – Ultramafic rock at the ground surface near exploratory trench T24-09.

No ultramafic rock, serpentinite, or NOA-containing minerals are to remain within six inches of finish grade at the completion of grading. The grading plans require the removal of approximately 4 vertical feet of soil and rock from the northeastern corner of the site to achieve the proposed finish subgrade elevation. As described in Section 6.1, we recommend that all ultramafic materials excavated from the northeastern corner of the site grading, as well as all undocumented fill and underlying expansive clay, be removed from the northeastern corner of the site and placed as deep engineered fill in the southeastern road alignment. These materials should not be placed within three vertical feet of the road subgrade elevation to reduce the possibility of disturbance during future utility trench excavation.
