PRELIMINARY GEOTECHNICAL ENGINEERING REPORT for BERRIMAN RANCH APN 22-140-03 and 22-160-03 Nevada County, California

Project No. 1746-02 December 13, 2006

Preliminary Geotechnical Engineering Report

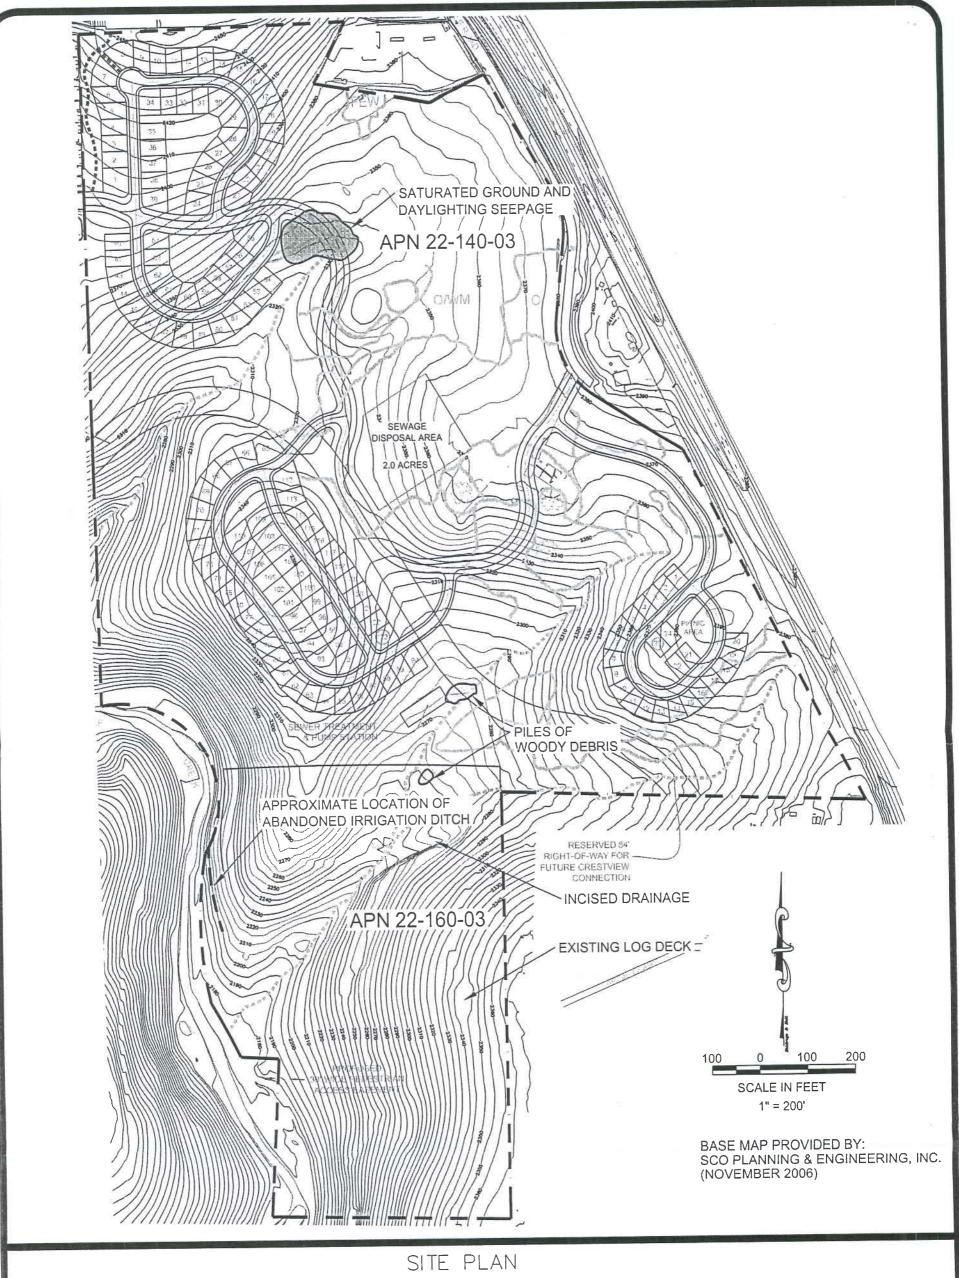
Figure 1 Site Plan

The approximate 120-acre site is located on the southwest-facing slopes directly west of Taylorville Road and Highway 49, approximately a quarter mile south of the intersection of Highway 49 and McKnight Way. The Assessor's Parcel Numbers (APNs) for the site are 22-140-03 and 22-160-03. APN 22-140-03 consists of approximately 95 acres which lie north of the rectangular shaped, approximate 25-acre APN 22-160-03. The site is bordered by commercial development at McKnight Way on the north, by Wolf Creek to the west, and by rural residential and undeveloped property to the south and east. A site map showing the approximate property boundaries is attached as Figure 1.

We observed an area of saturated ground and daylighting seepage east of proposed Lot 55 in an area of proposed road grading. We also observed what appeared to be an abandoned irrigation ditch in the northwestern corner of APN 22-160-03 (Figure 1).
