***PRELIMINARY GEOLOGIC
HAZARDS REPORT
for
THE VILLAGE AT SOUTHHILL
Nevada County, California***

***Project No. 3594-01
October 10, 2008***

Reference: *The Village at SouthHill*
Nevada County, California

Subject: *Preliminary Geologic Hazards Report*

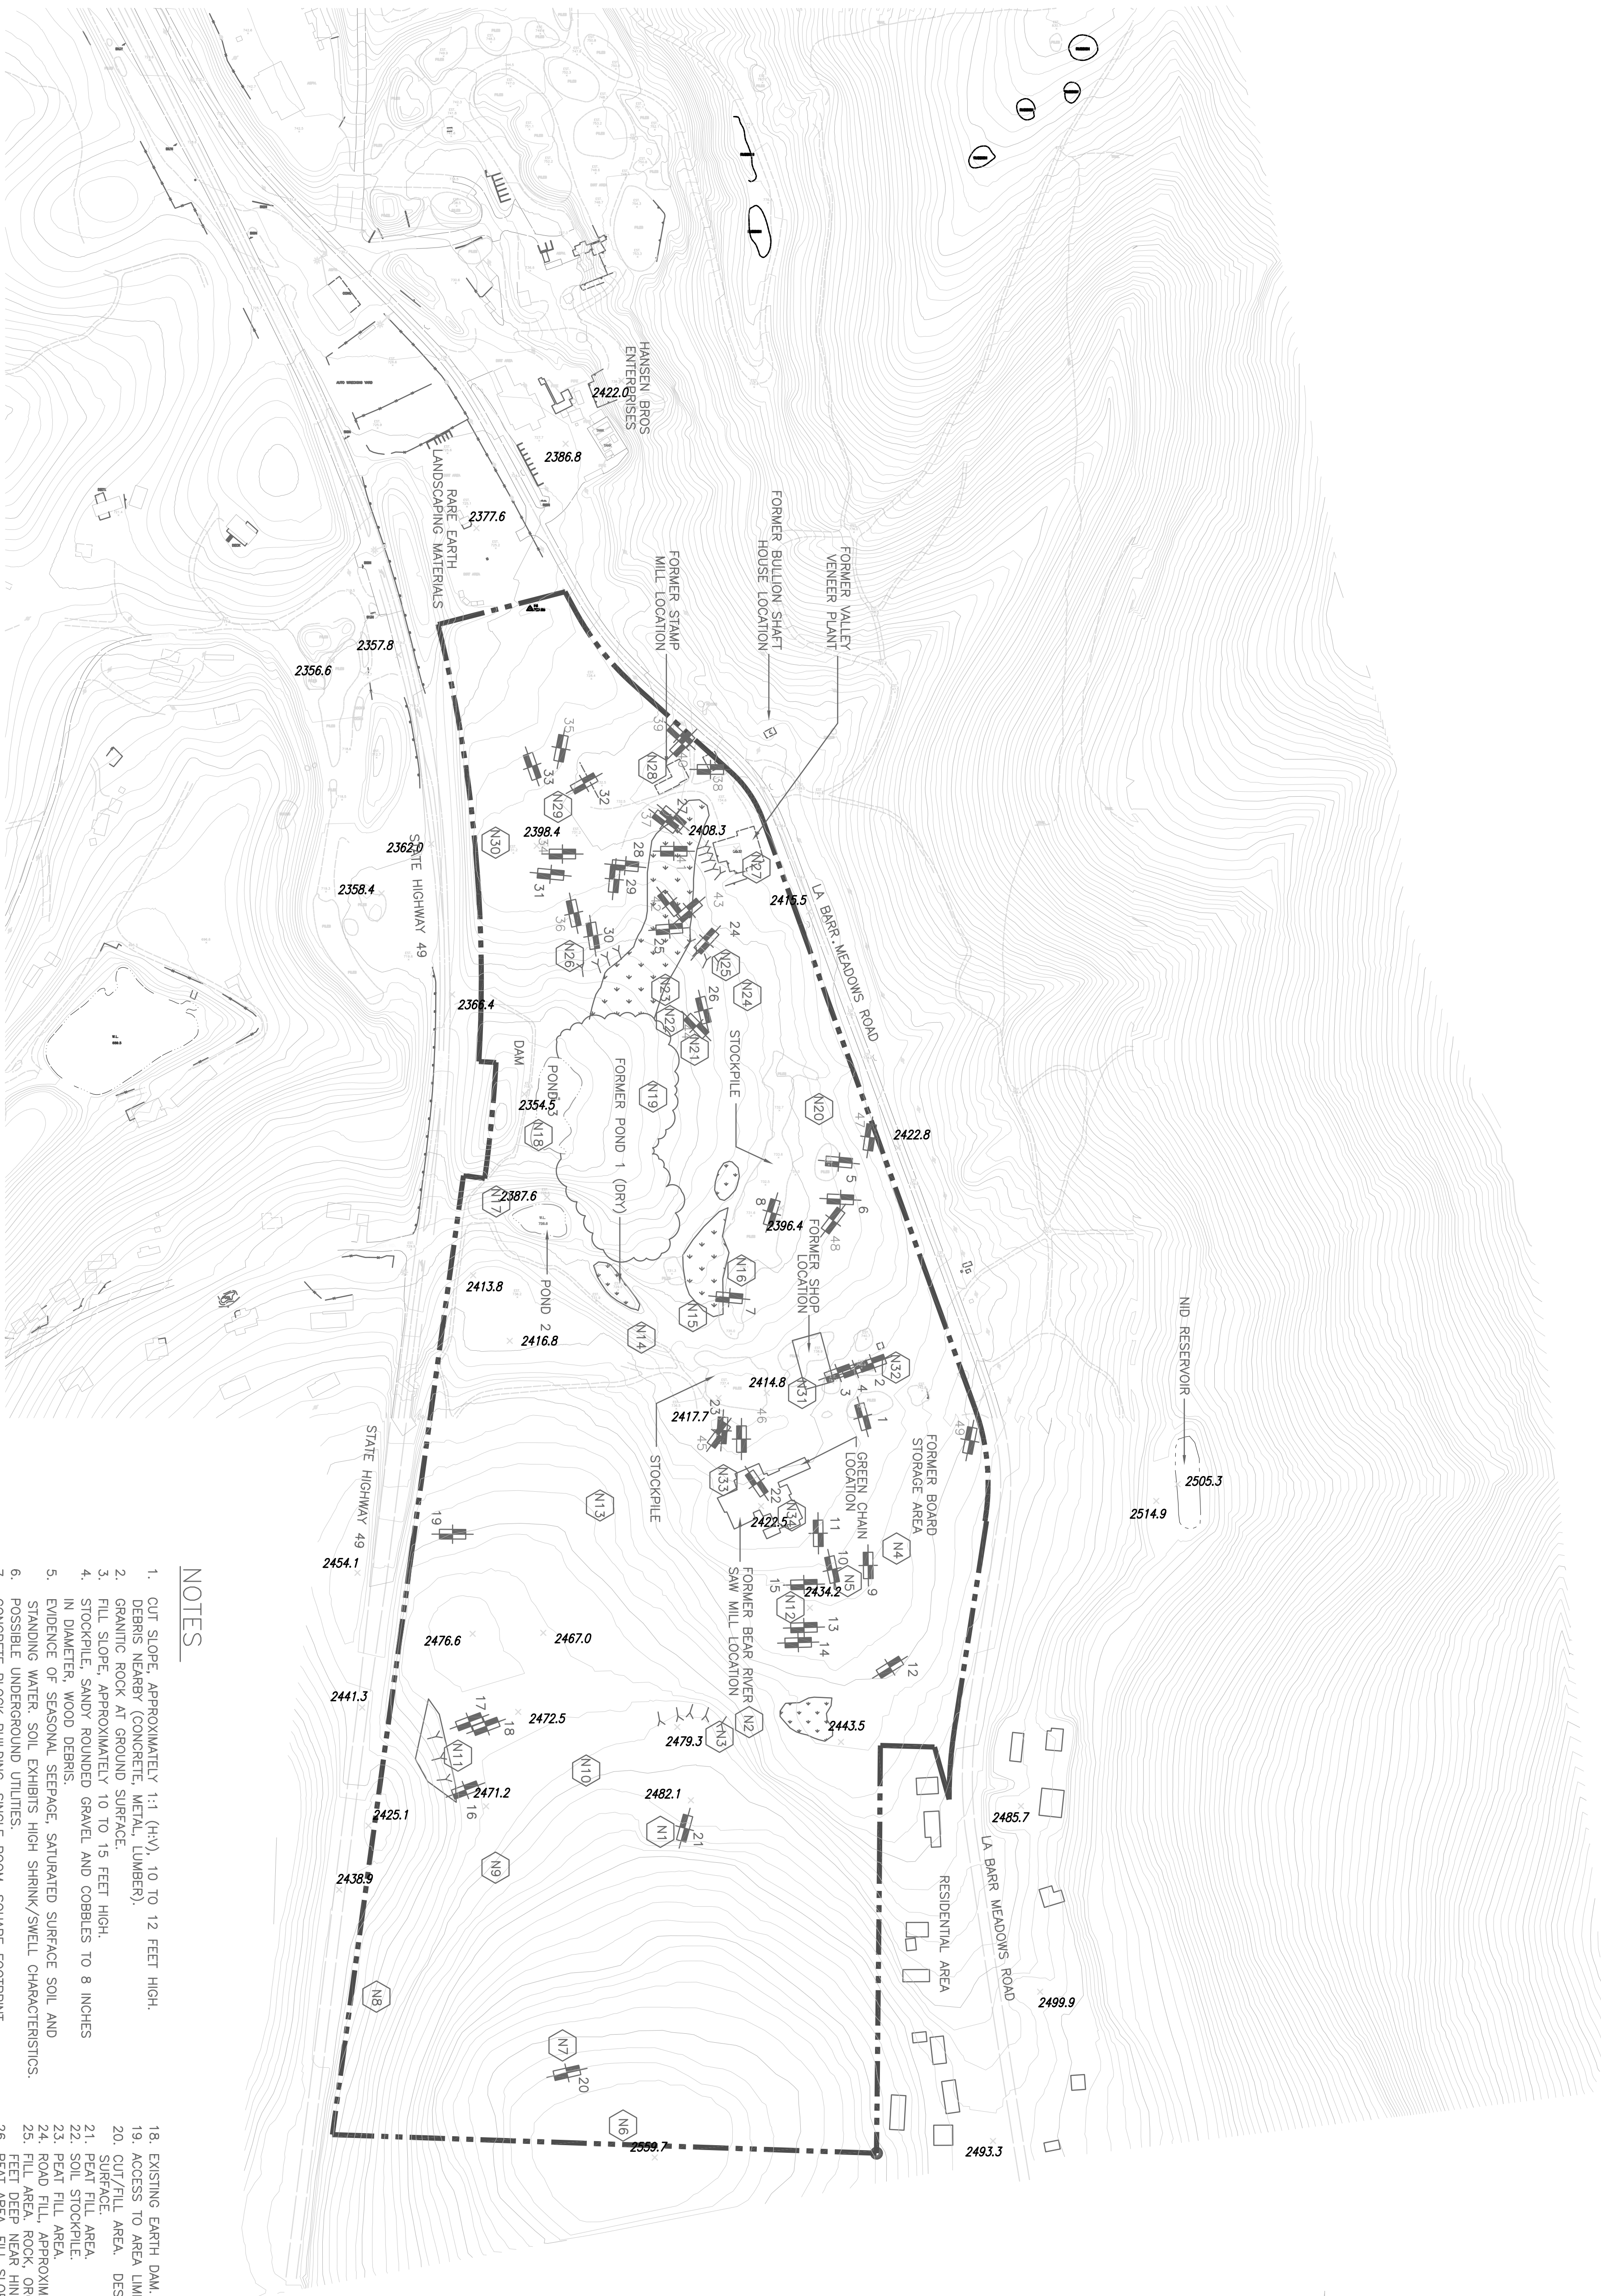
Sheet 1 Site Map

A significant amount of debris was observed in the vicinity of the historic mill operations (Sheet 1). Reinforced concrete slabs-on-grade, concrete foundations, rubble and debris piles were common in the central east and northeast portions of the site. Many stockpiles in this area contained debris and organic material and would not be suitable for use as structural fill.

H&K encountered seepage and/or shallow groundwater at depths of 2 to 8 feet bgs in the alluvial areas, which are located predominantly on the eastern side of the site, and in the vicinity of the ponds on the western side of the site. Seepage was commonly observed along the upper surface of the clay and clayey silt typically found at a depth of approximately 5 feet bgs in the alluvial areas. Evidence of seasonal flooding and soil saturation was common. Seepage and standing water was observed at the ground surface in and near saturated areas, as shown on Sheet 1.

The soil conditions described in the following paragraphs are generalized, based on a review of subsurface descriptions resulting from H&K's exploratory trenching in 1999 and 2001. Detailed descriptions of subsurface conditions are presented in trench logs 1 through 49 in Appendix A. Trench locations are depicted on Sheet 1.

Numerous debris stockpiles were observed throughout the graded areas in the central and northern portions of the site. Exploratory trenches 1, 2, 3, 5, 9, 28, 29 and 32 were excavated in debris stockpiles that appeared to be representative of other stockpiles in the immediate vicinity. The majority of the debris stockpiles observed contained a significant amount of wood waste and would not be suitable for use as structural fill. A number of shallow rubbish fills were also observed throughout the site. Some of the more notable areas of debris and rubbish observed at the site are noted on Sheet 1.

SITE MAP
THE VILLAGE AT SOUTHHILL
NEVADA COUNTY, CALIFORNIA

The soil survey depicts Alluvial Land in the central and eastern portions of the site. Alluvial Land is characterized by clayey soil of slow to very slow permeability. Runoff is typically slow and flooding is common during the rainy season. Clayey alluvial deposits are likely to exhibit high shrink/swell characteristics when subjected to moisture variation. H&K typically observed firm clay and medium dense, clayey silt at depths of 3 to 6 feet bgs in the exploratory trenches excavated in the lower, eastern portions of the site. Standing water, saturated surface soil, and evidence of seasonal flooding was common in these areas, as depicted approximately on Sheet 1.

Clayey, potentially expansive soil was encountered in trenches 4, 10, 14, and 15 (Sheet 1), which were excavated in an area mapped as alluvium (Sheet 2) in the central-eastern portion of the site. The results of laboratory swell testing performed as part of H&K's 1999 investigation indicates that some of the soil tested has high expansion potential. The presence of potentially expansive soil within proposed improvement areas should be evaluated as part of a design-level geotechnical investigation for the project, and recommendations for mitigation of expansive soil should be based on the findings of the investigation.

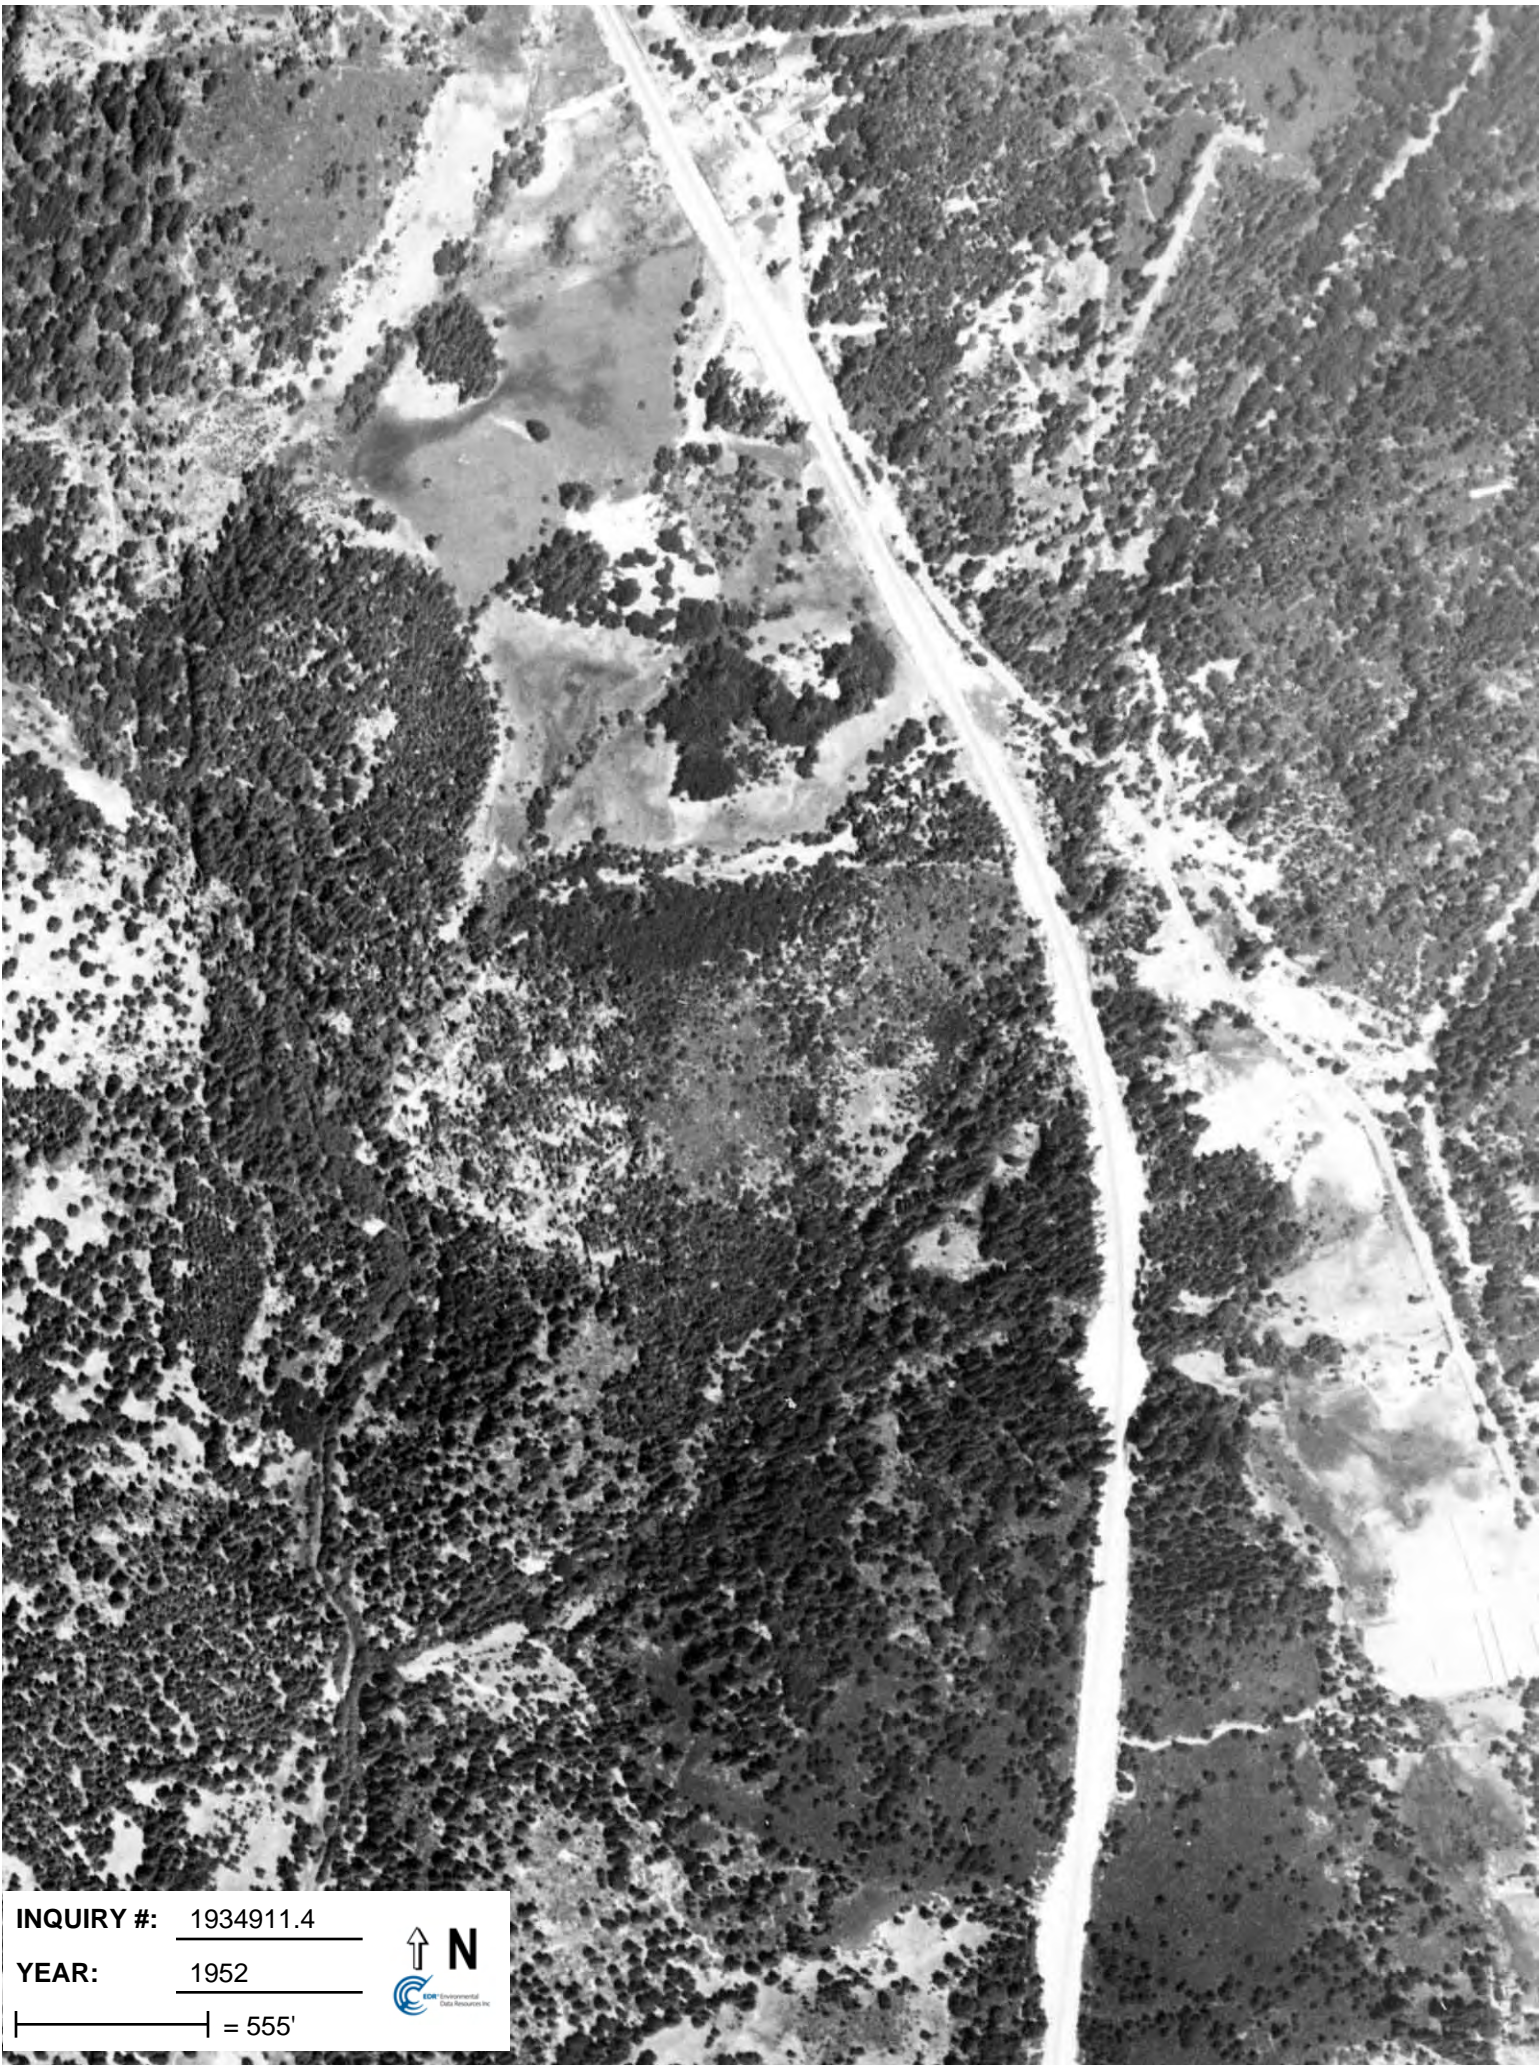
YEAR: 1952

The 1952 aerial photograph post-dates the majority of hard-rock gold mining activity in the site vicinity, but pre-dates the reported development of lumber milling facilities at the site. The photograph is of poor resolution and depicts disturbed soil conditions across the eastern and central portions of the site. Structures/and or foundations are faintly visible in the southeastern portion of the site. Roads are visible along the approximate current alignments of State Route 49 and La Barr Meadows Road. Little evidence of development is apparent on adjacent properties in the immediate site vicinity.

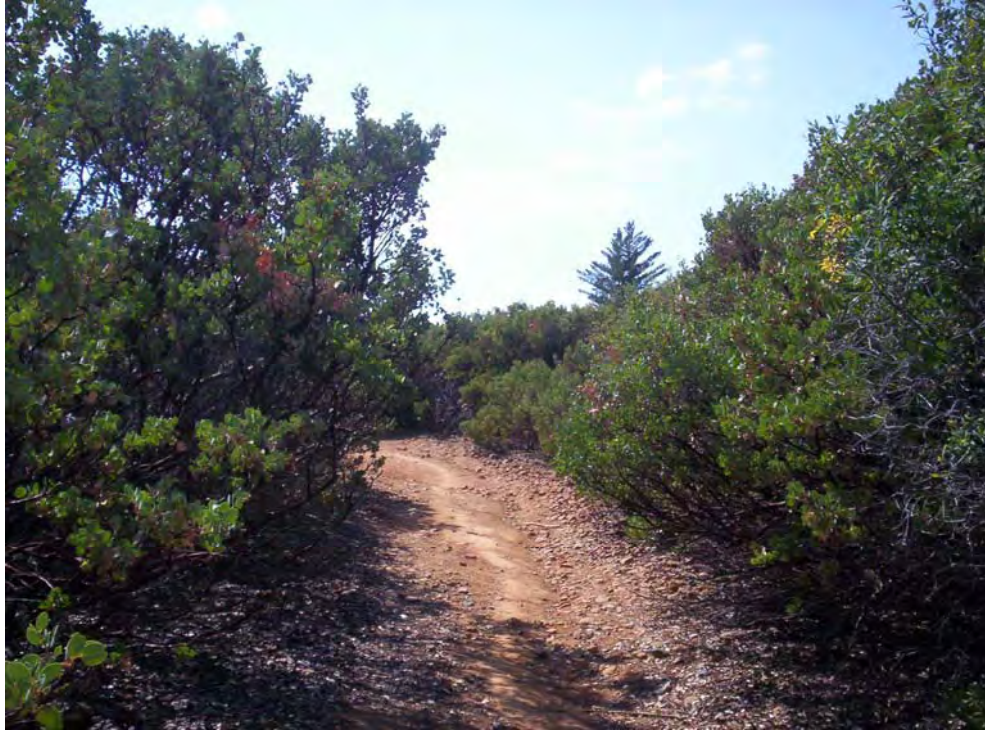
Photo 1. Dense manzanita near southern site boundary.

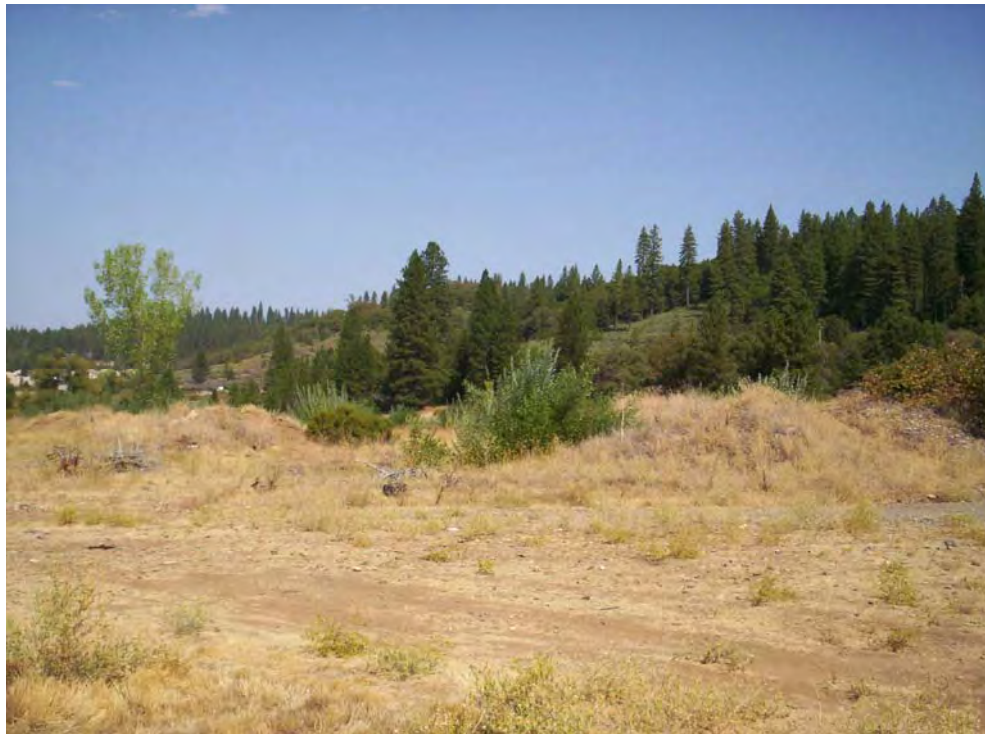
Photo 2. Stockpiles near exploratory trench location 1 viewed from the southwest.

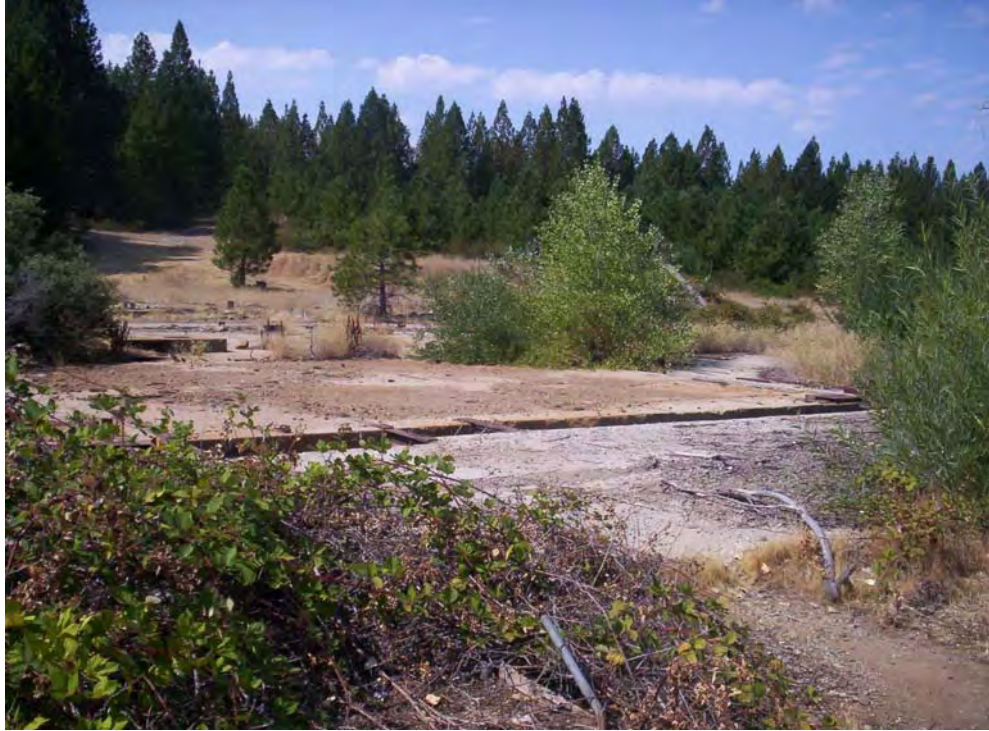
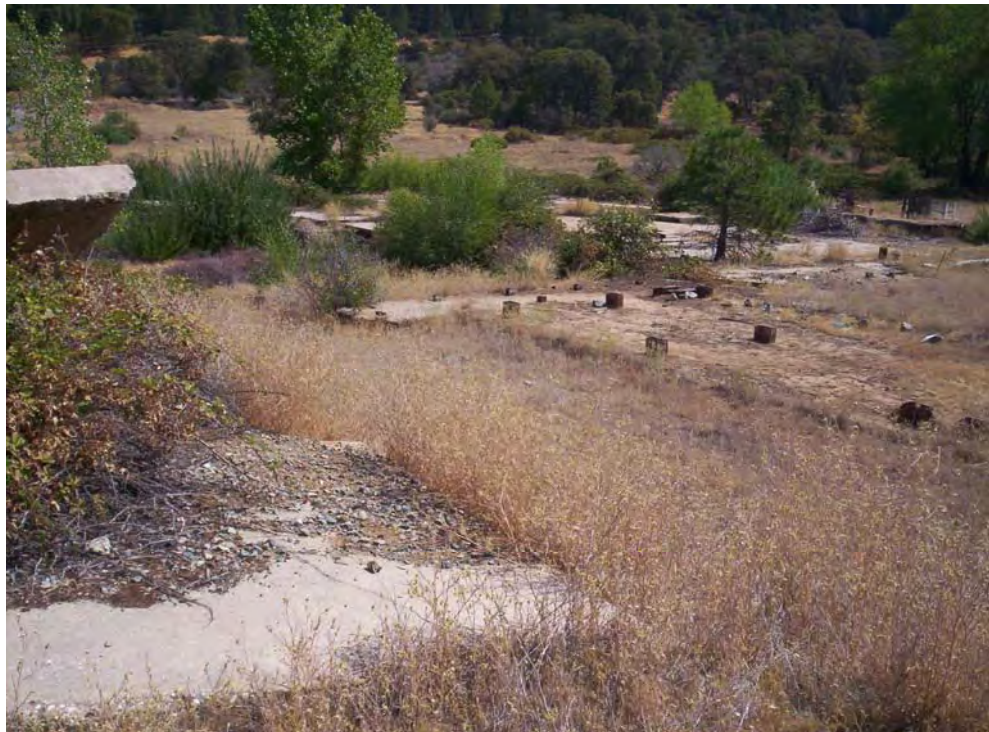
Concrete slabs-on-grade up to 14 inches thick covered the ground surface across much of the former Bear River Sawmill location (Photos 3 and 4). Reinforcement in the slabs and walls, where exposed, consisted of No. 5 rebar. Steel up to $\frac{7}{8}$ inches thick was embedded in the concrete slabs. Several stockpiles of broken concrete and other debris were observed in the vicinity of the mill site. An adjacent concrete foundation exposed in exploratory trench 11 extended from 2 feet to deeper than 8 feet bgs. Shallow fill was common in the area of the mill site. H&K observed layers of gravel, clay, clean sand, and organic debris to depths of approximately 6 feet bgs near the mill site.

Photo 3. Former Bear River Saw Mill location viewed from the east.

Photo 4. Former Bear River Saw Mill location viewed from the west.

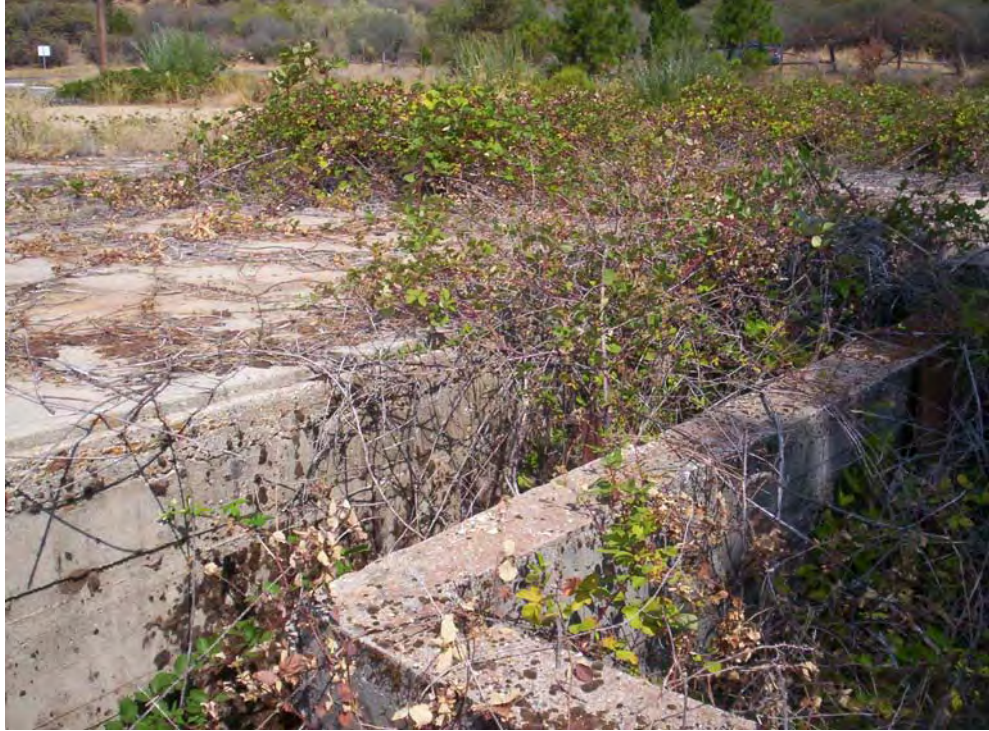
Angular rock fill was encountered west, northwest and southwest of an existing concrete slab-on-grade located at the former Valley Veneer Plant location (see exploratory trenches 27, 37, 41, 42 and 43). The rock fill extended to approximately 8 feet bgs at the location of trenches 27 and 37. Granitic and metamorphic rock fragments to 12 inches in diameter with significant mineralization were observed within the fill.

Photo 5. Former Valley Veneer Plant location viewed from the southwest.

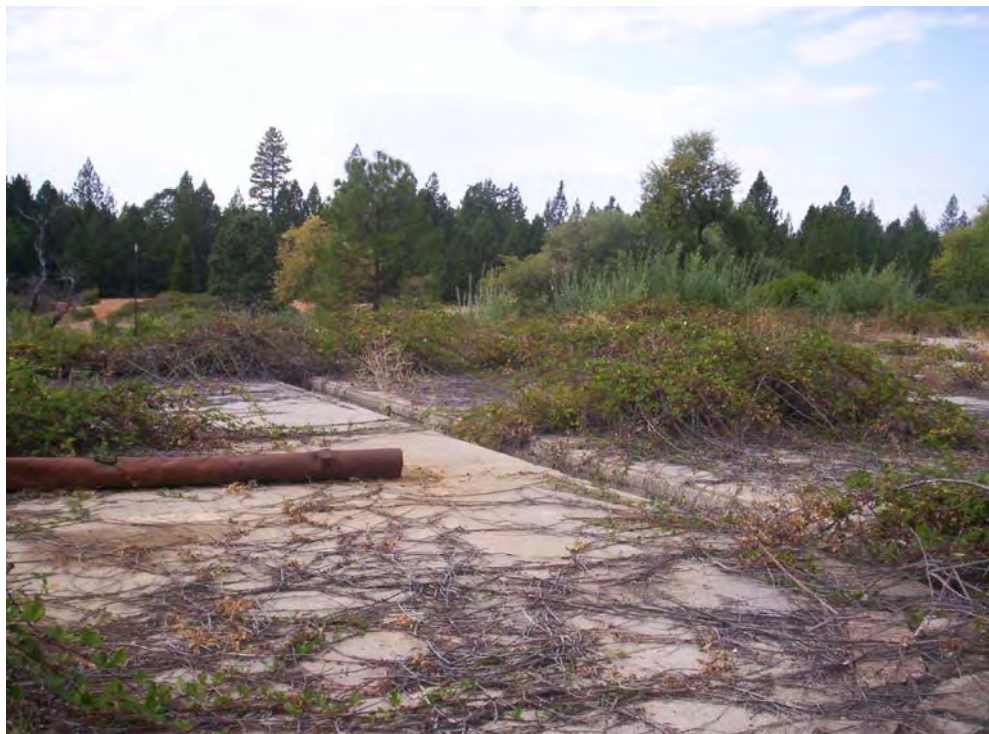
Photo 6. Former Valley Veneer Plant location viewed from the east.

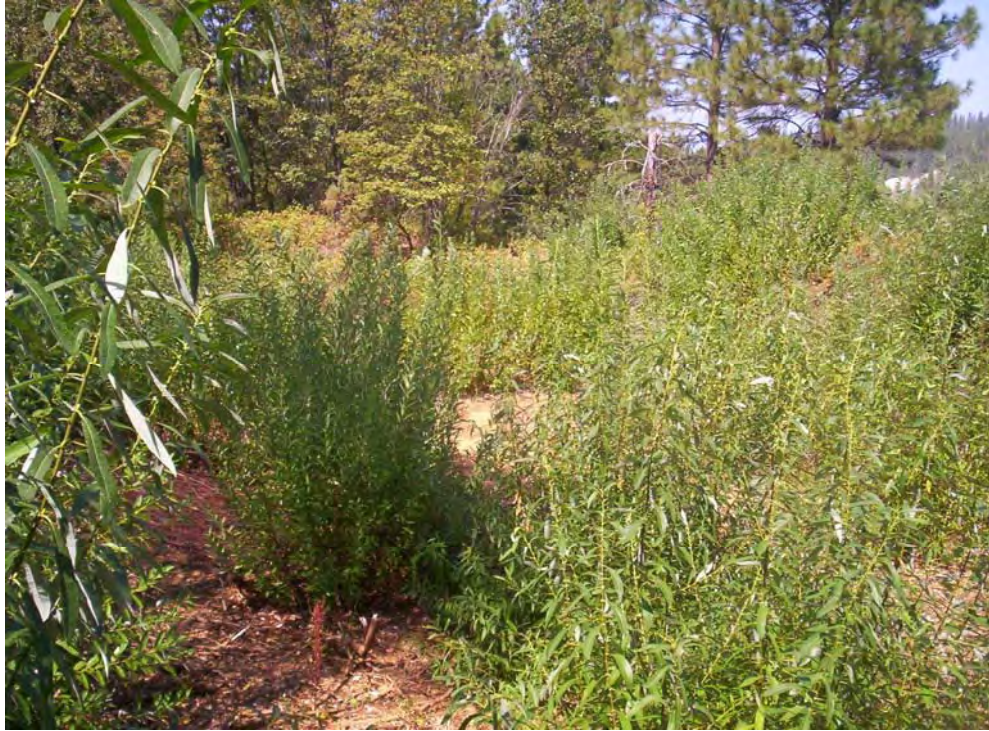
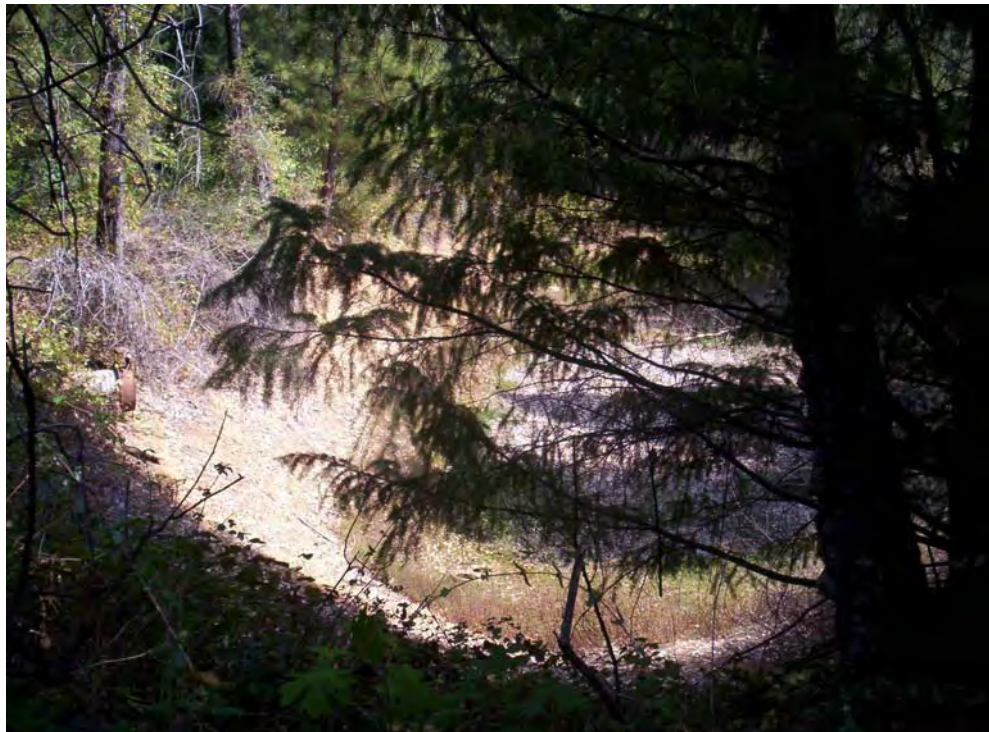
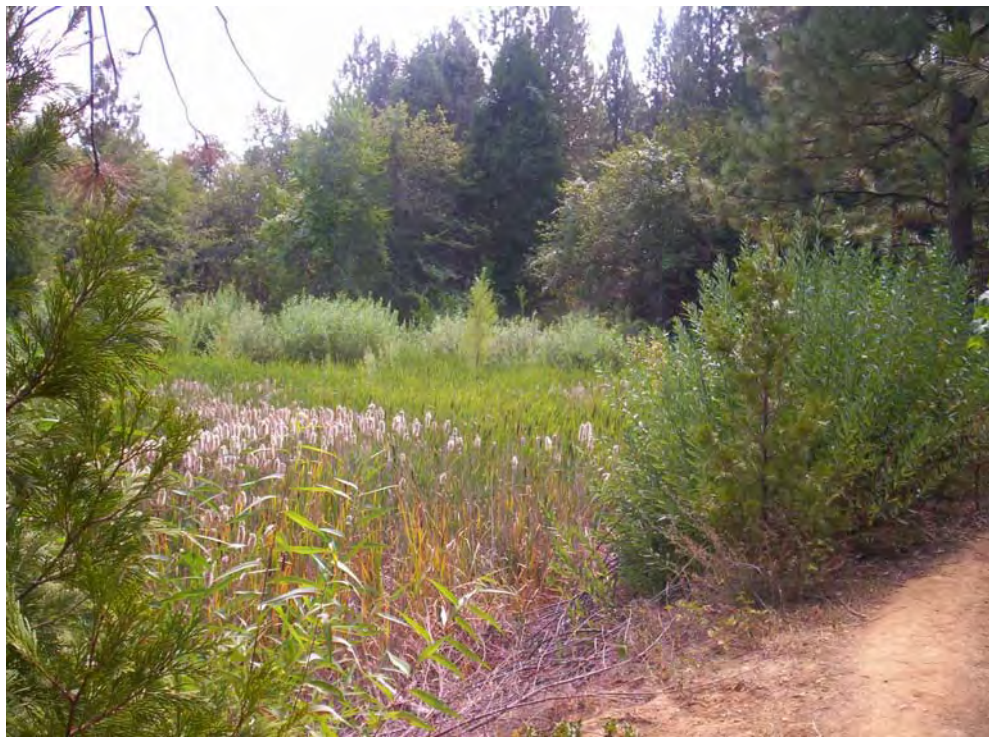
H&K observed several areas of saturated surface soil, standing water or riparian vegetation on the site. Evidence of seasonal ponding and poor drainage was common in the central portion of the property. Two ponds were located near the western property boundary. The earth dam for the larger pond had apparently experienced a significant amount of seepage. The dam had been breached at least once, as evidenced by erosion over the top of the dam. A third, dry pond was identified southeast of the existing ponds.

Photo 7. Former Pond 1 (dry).

Photo 8. Pond 2 (dry).

Photo 10. Pond 3.

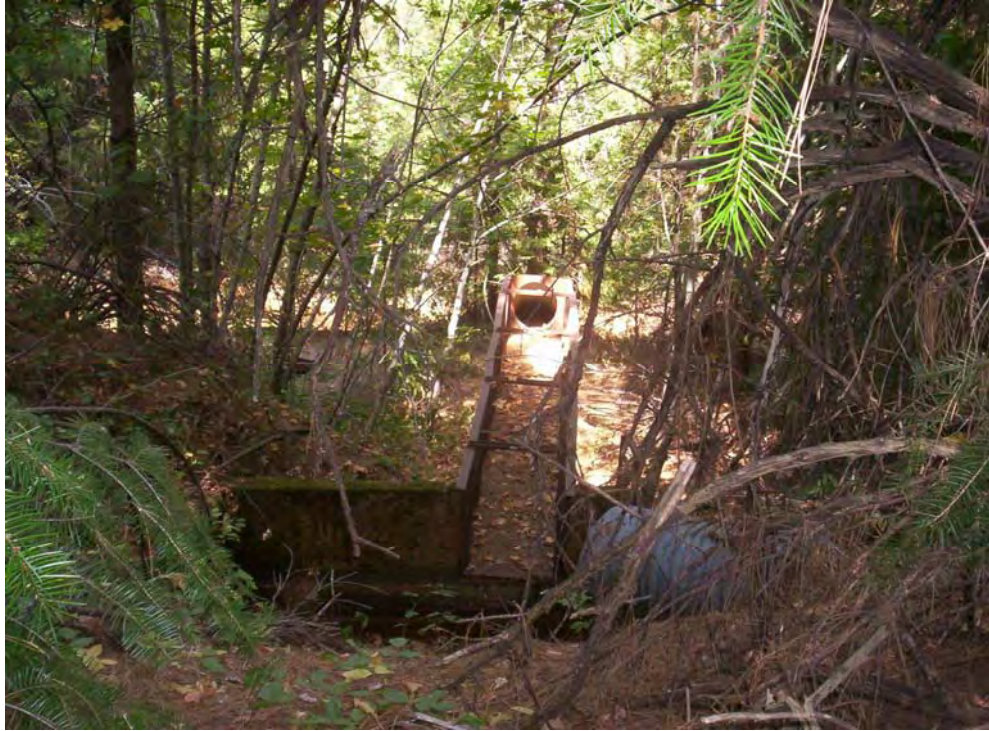
Photo 9. Pond 2 outlet structure.
